# NATIONAL TRANSPORTATION SAFETY BOARD

## AIRCRAFT ACCIDENT REPORT

IN-FLIGHT ICING ENCOUNTER AND  
UNCONTROLLED COLLISION WITH TERRAIN  
COMAIR FLIGHT 3272  
EMBRAER EMB-120RT, N265CA  
MONROE, MICHIGAN  
JANUARY 9, 1997

**Abstract:** This report explains the accident involving an EMB-120RT, operated by COMAIR Airlines, Inc., as flight 3272, that crashed during a rapid descent after an uncommanded roll excursion near Monroe, Michigan, on January 9, 1997. Safety issues in the report focused on procedures for the use of ice protection systems, airspeed and flap configuration information, stall warning/protection system capabilities, operation of the autopilot in icing conditions, aircraft icing certification requirements, and icing-related research. Safety recommendations concerning these issues were addressed to the Federal Aviation Administration and the National Aeronautics and Space Administration.

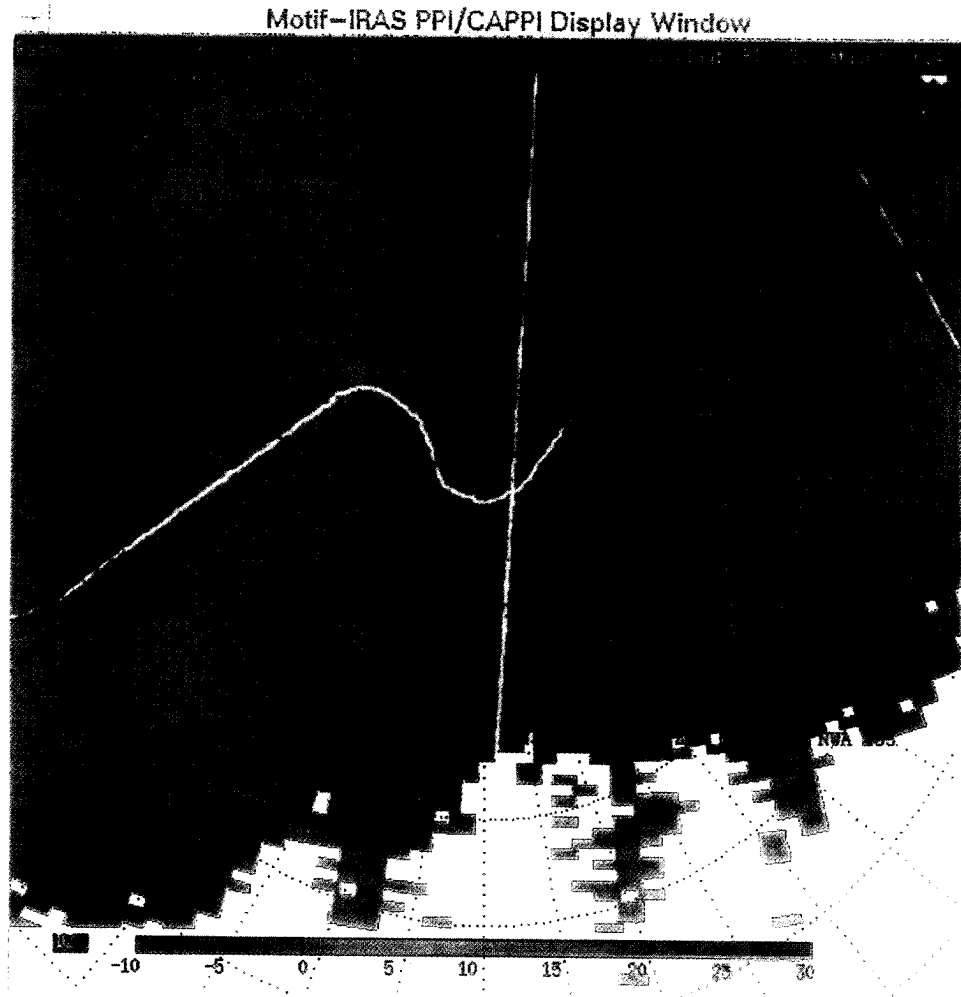
Figure 8.--Flightpath and weather radar echo information.

Doppler weather radar images from the National Weather Service weather radar at White Lake, Michigan. Image time is 2055:05Z. Ground tracks of Comair 3272 [red], Cactus 50 [yellow], Northwest 272 [blue], and Northwest 483 [black] plotted. Weather echo intensities [dBZ] color coded corresponding to color bar at bottom of images. Range rings every 10 kilometers. Azimuth radials every 10 degrees. True north to top of the image.

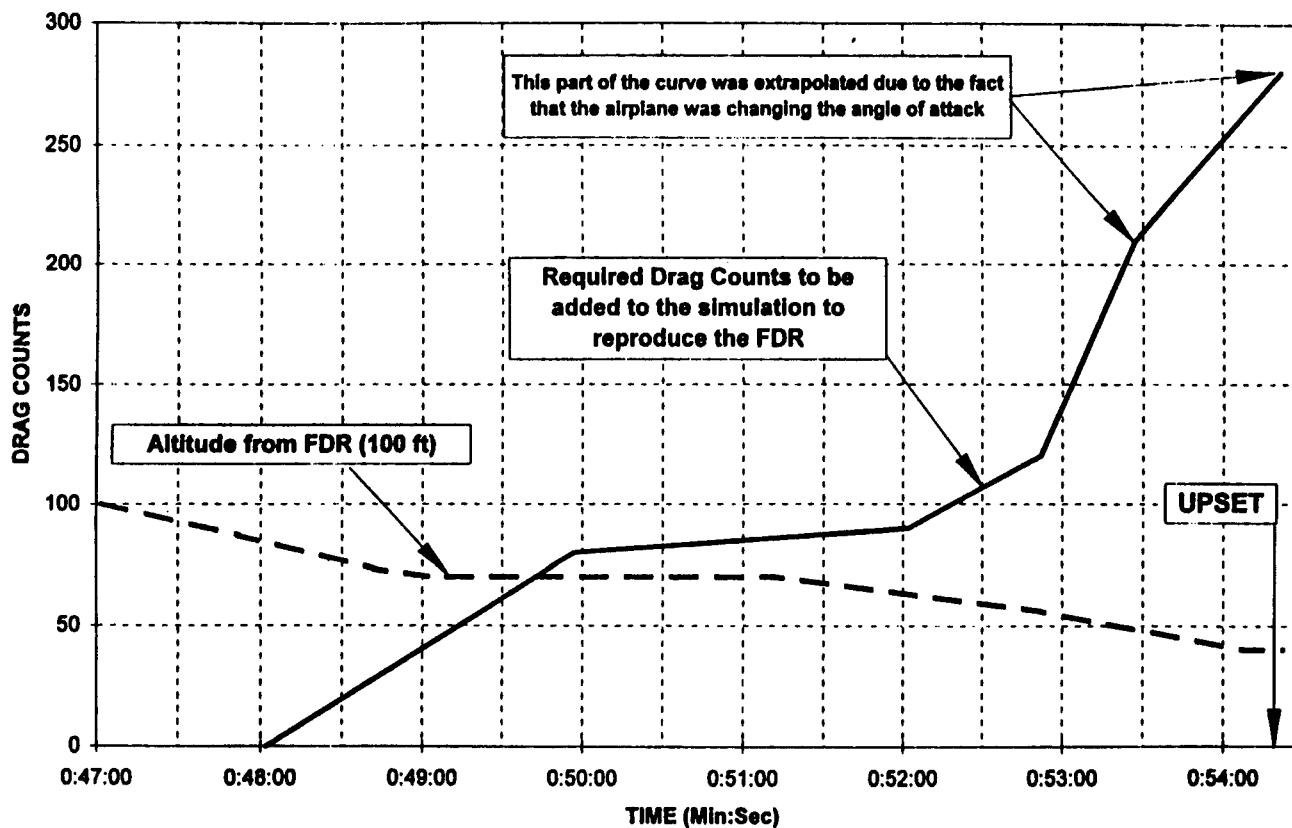
**FIGURE 5 - COMAIR FLIGHT 3272  
DRAG INCREASE FROM COMPARISON - FDR AND SIMULATION •**

The analysis shows that the aerodynamic degradation started near DFDR time 48:00 and lasted for about 6 minutes. The increase in drag is not linear with time or altitude and a small variation is noticed during the period of time from 50:00 to 52:00. After that, the rate of increase in drag is pronounced, particularly between 52:50 and 53:30.
